**G9721.01-113-11-R1  
ACOUSTICAL PERFORMANCE TEST REPORT  
ASTM E90**

**METAL BUILDING MANUFACTURERS ASSOCIATION  
AND  
NORTH AMERICAN INSULATION MANUFACTURERS ASSOCIATION**

**TEST SPECIMEN: R-1, Roof Assembly**

**G9721.02-113-11-R1  
ACOUSTICAL PERFORMANCE TEST REPORT  
ASTM E90**

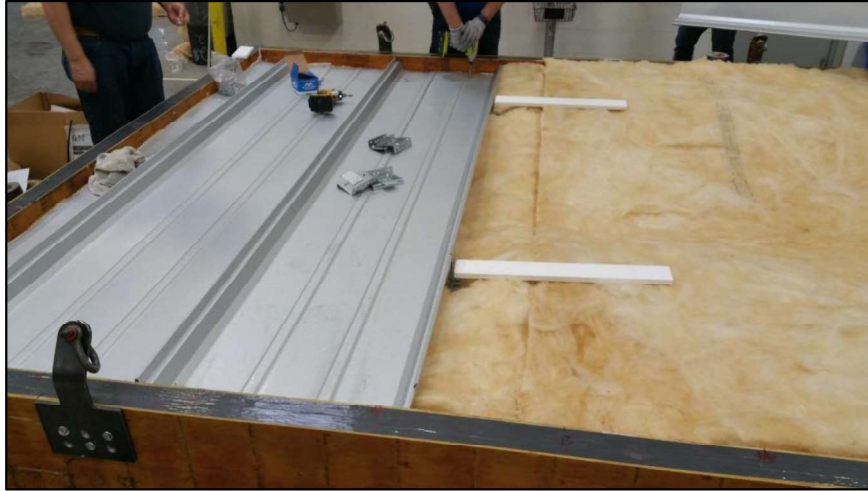
**Construction of Test Specimen**

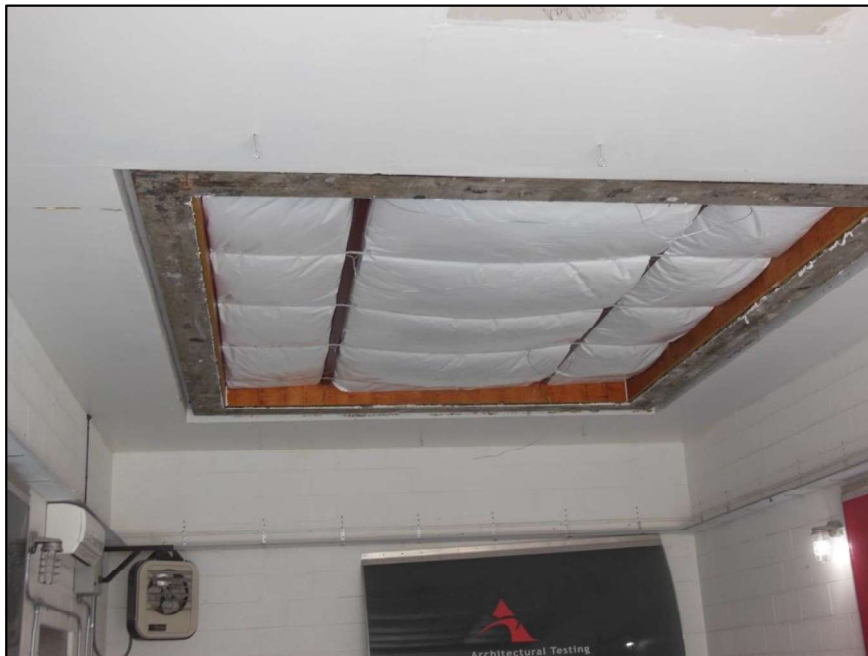
**Receive Room View of Test Specimen Installation**

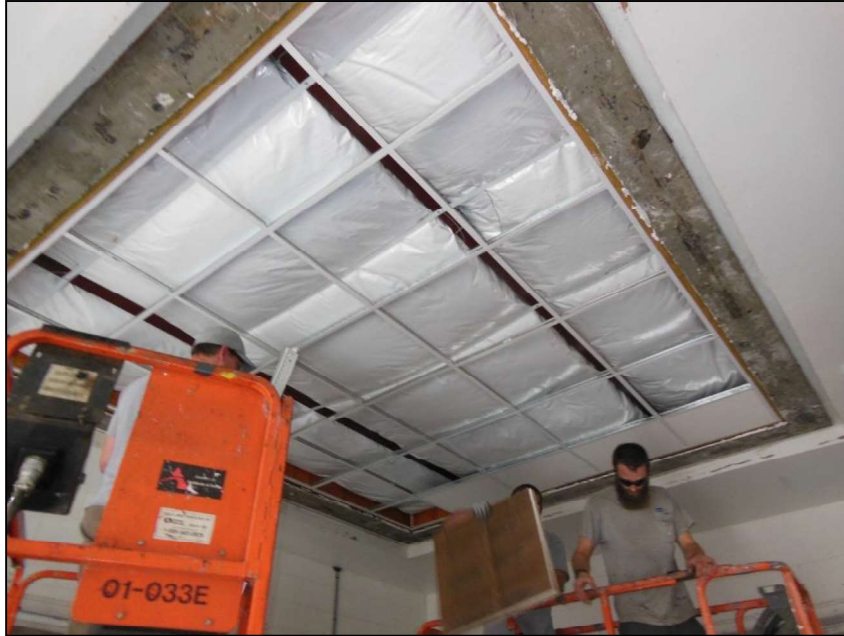
**Construction of Test Specimen**

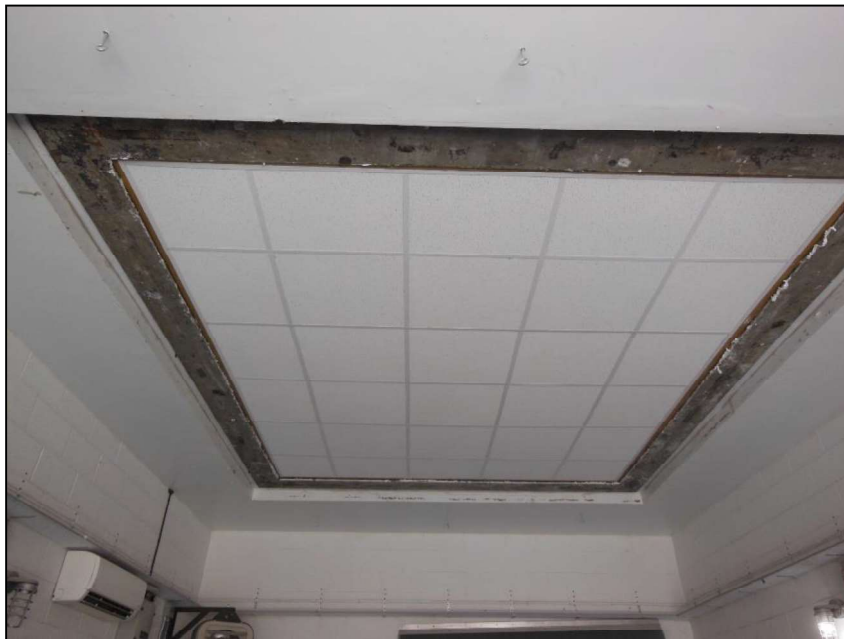
**Receive Room View of Test Specimen Installation**

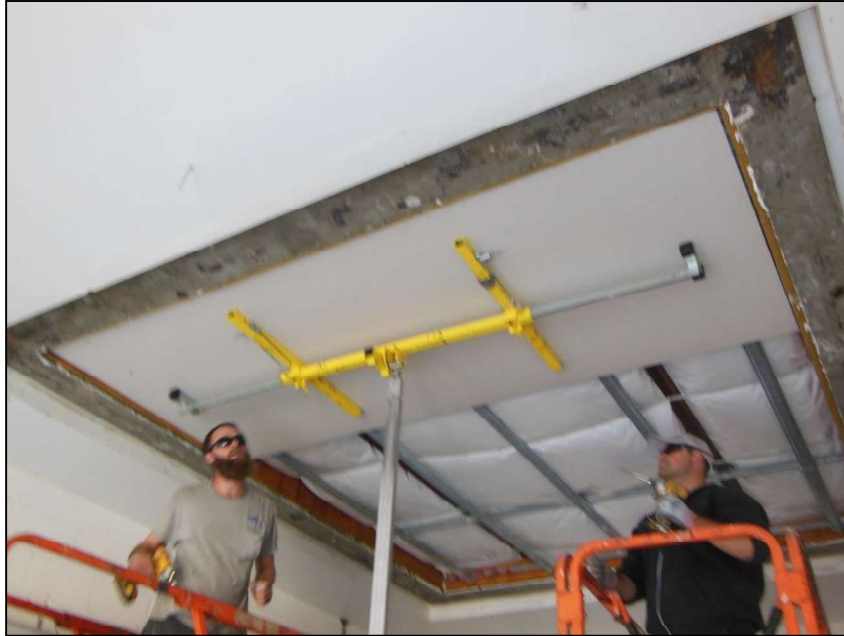
**Construction of Test Specimen**

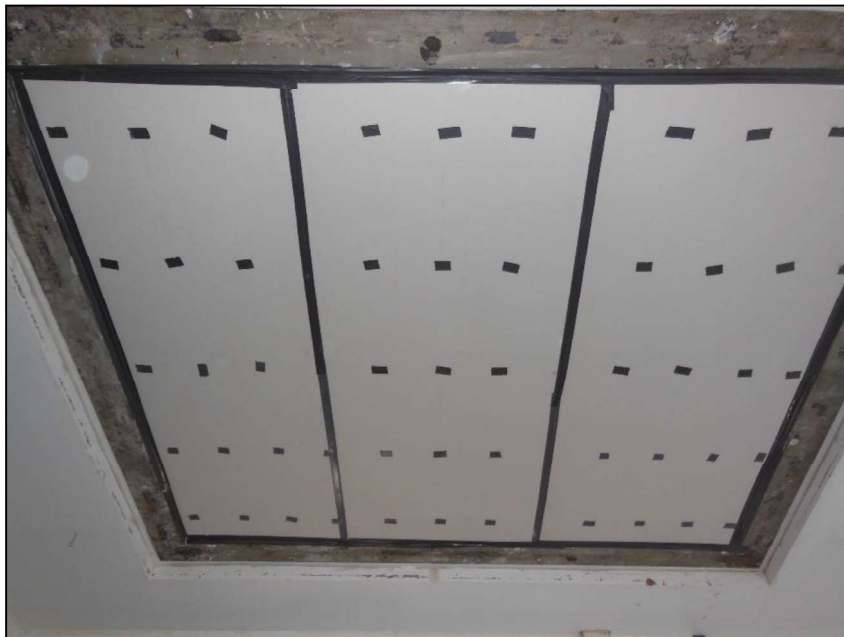
**Receive Room View of Test Specimen Installation**

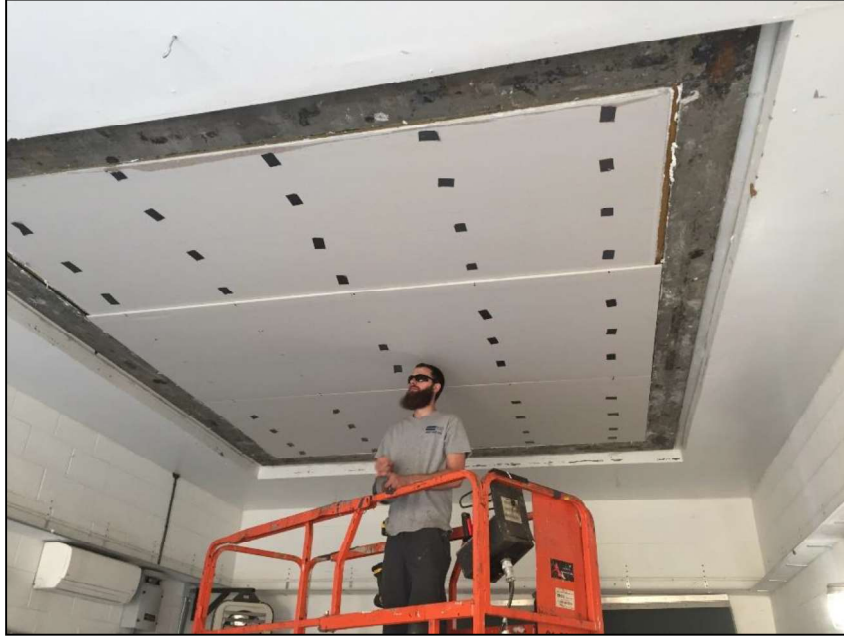
**Construction of Test Specimen**

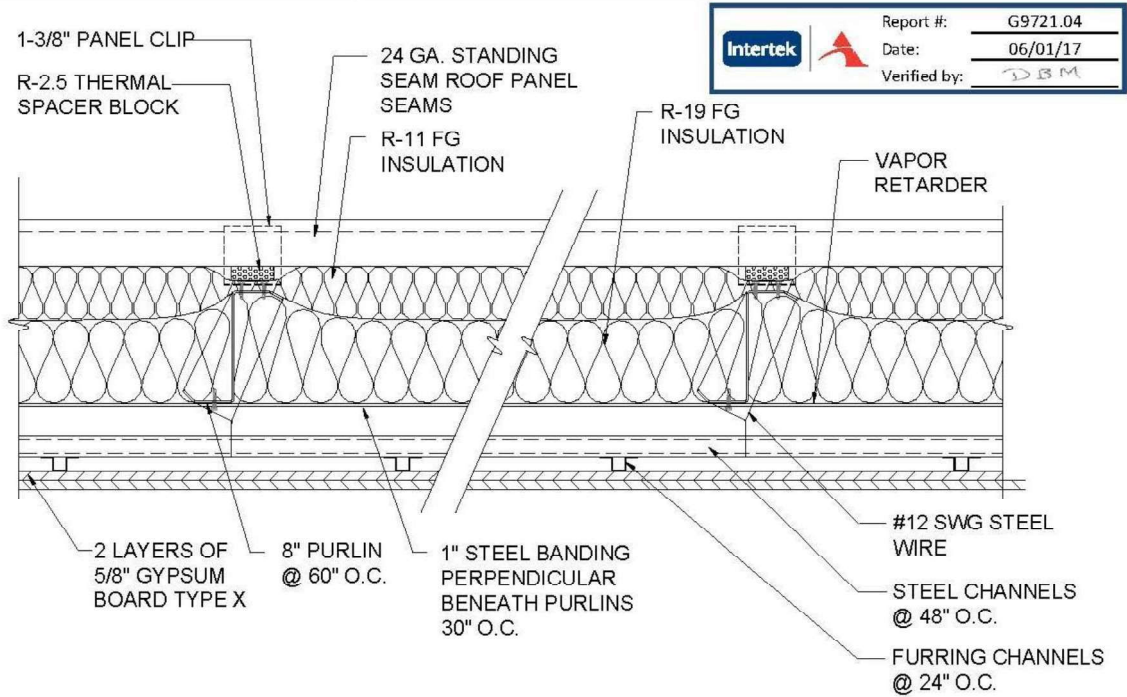
| Data File No. G9721.04 | |

| STC: 58 | OITC: 46 |
