**G9722.01-113-11-R2  
ACOUSTICAL PERFORMANCE TEST REPORT  
ASTM E90**

**METAL BUILDING MANUFACTURERS ASSOCIATION  
AND  
NORTH AMERICAN INSULATION MANUFACTURERS ASSOCIATION**

**TEST SPECIMEN: W-1, Wall Assembly**

## Acoustical Performance Test Report

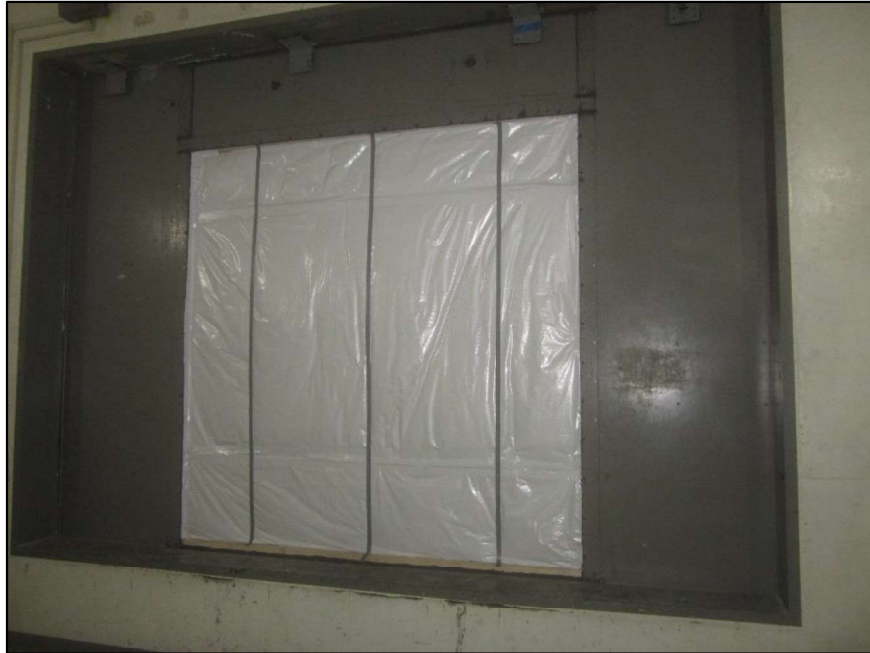
**Receive Room View of Installed Specimen**

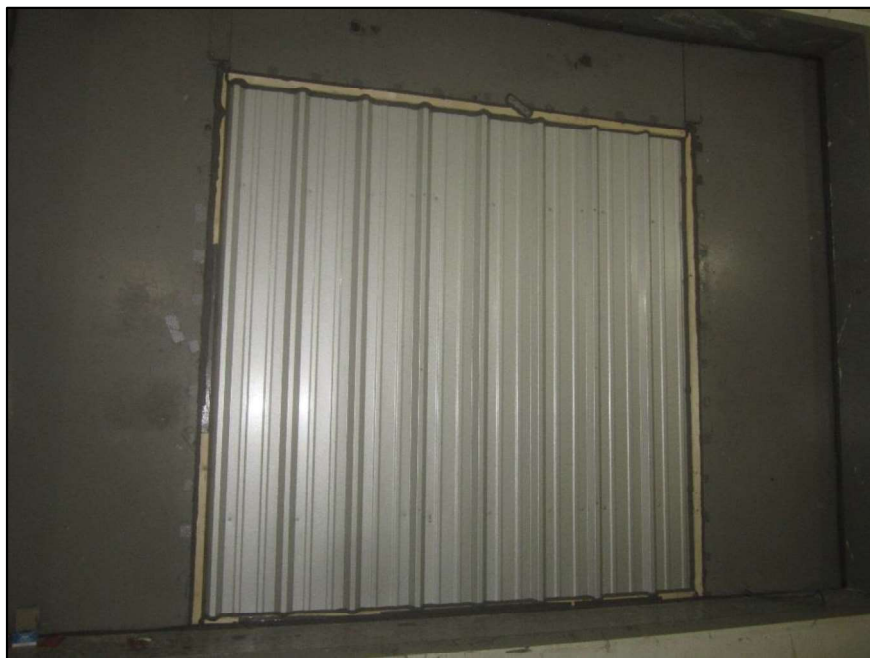
**Source Room View of Installed Specimen**

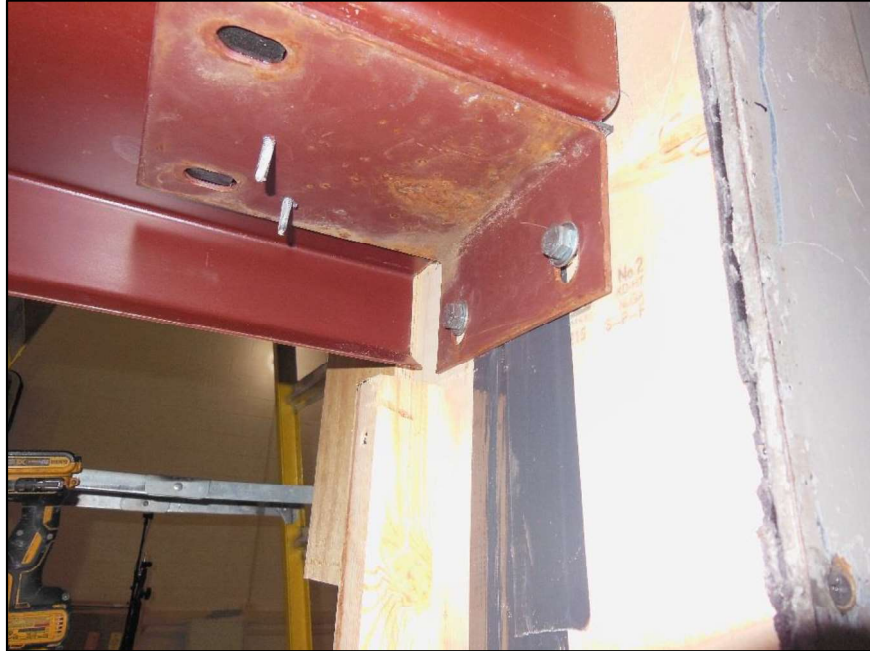
**Girt with Support Bracket**

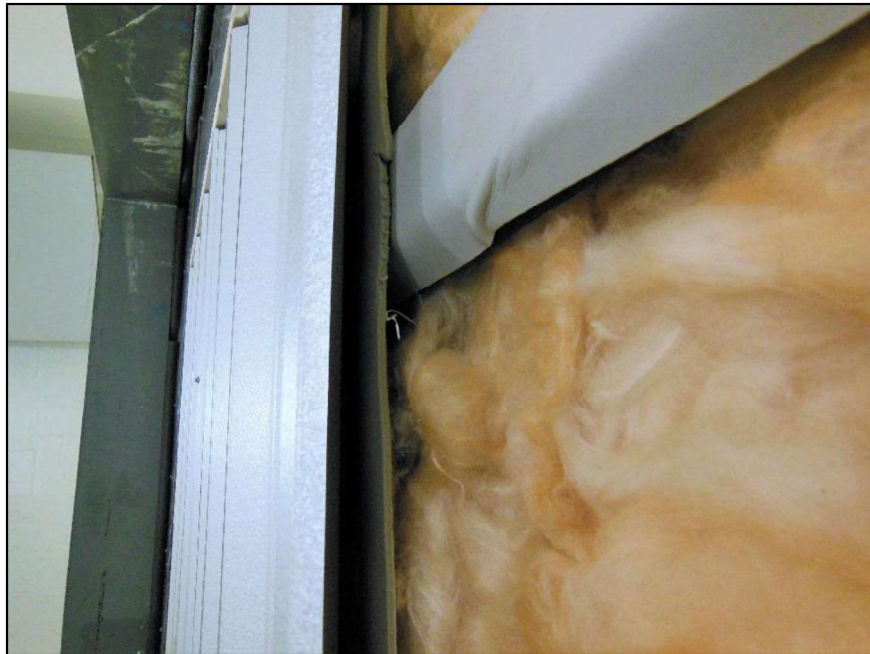
**Isolator Foam with Metal Panel**

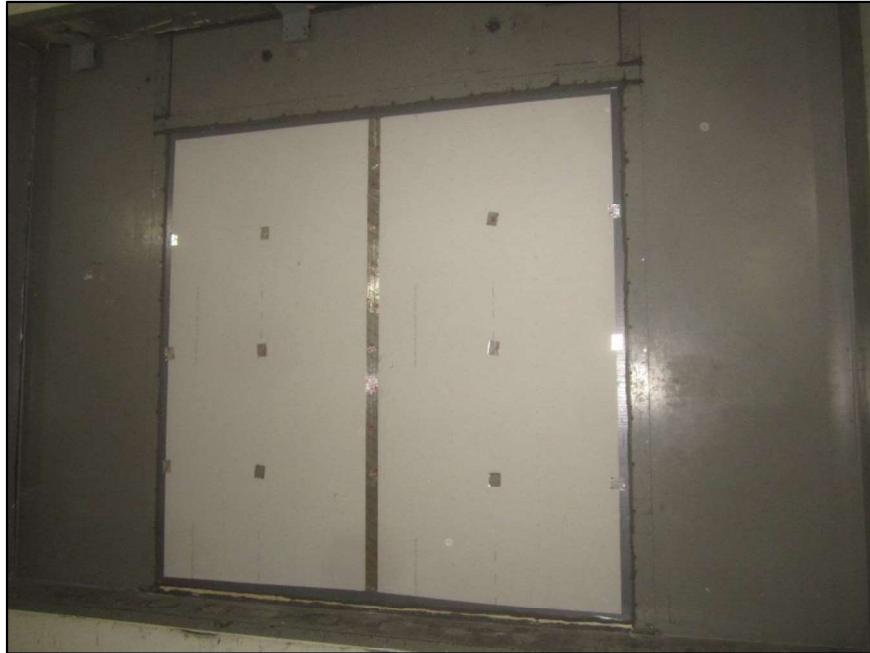
**Receive Room View of Installed Specimen**

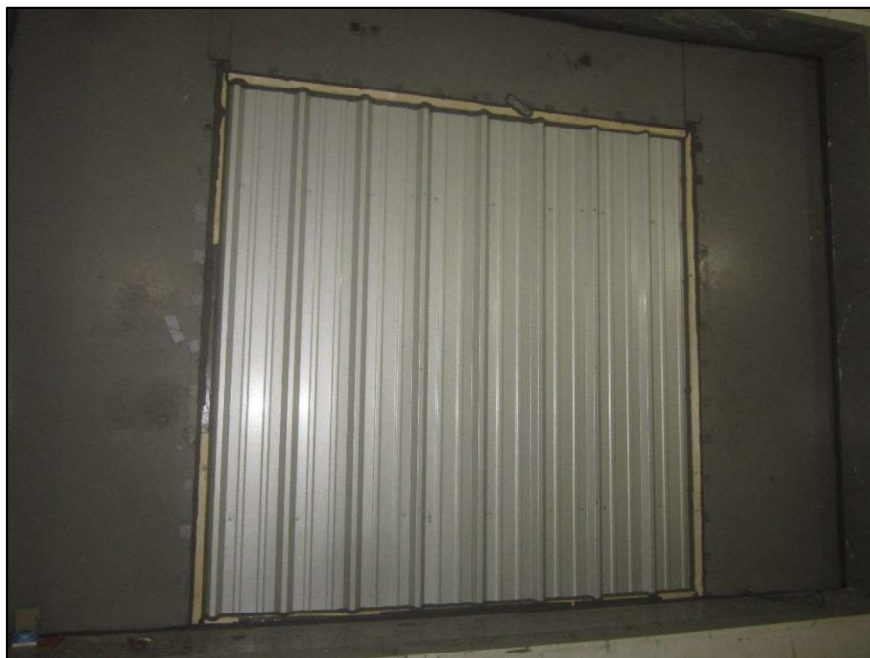
**Source Room View of Installed Specimen**

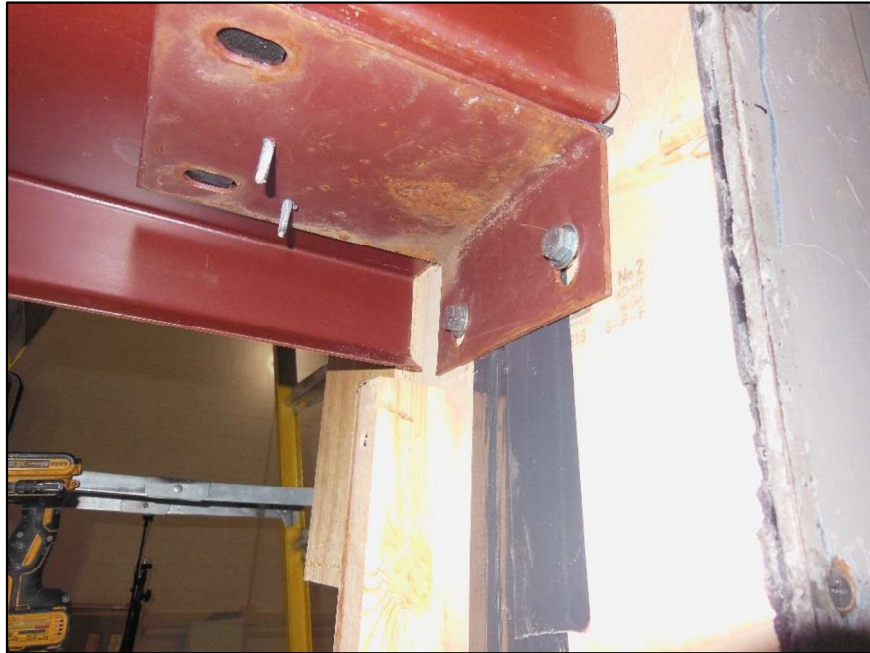
**Girt with Support Bracket**

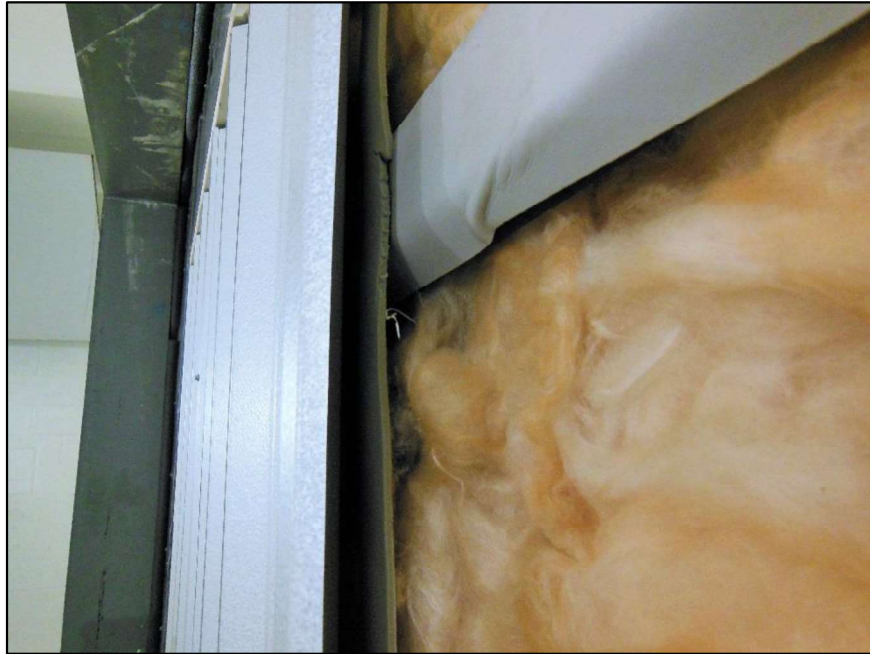
**Isolator Foam with Metal Panel**

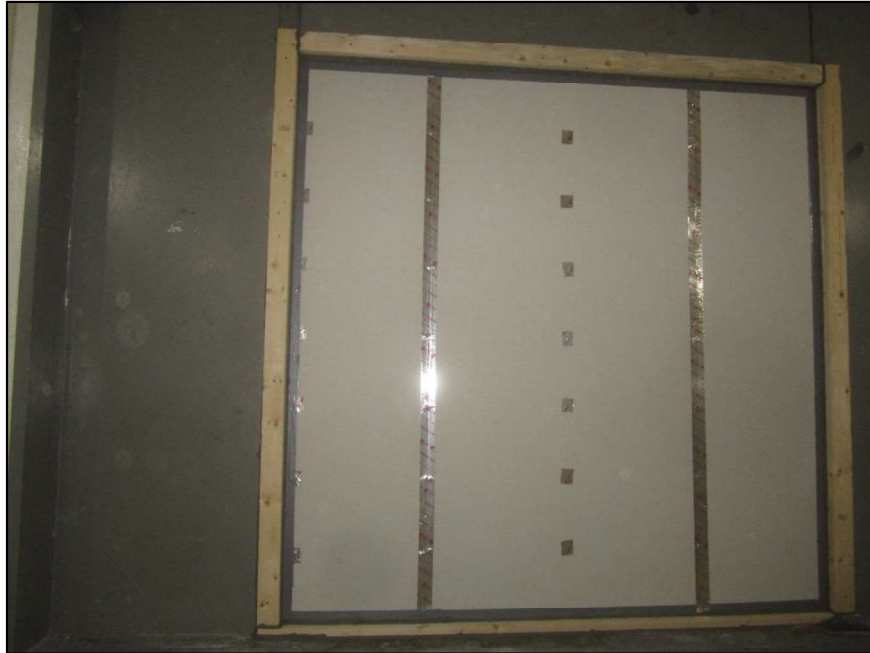
**Receive Room View of Installed Specimen**

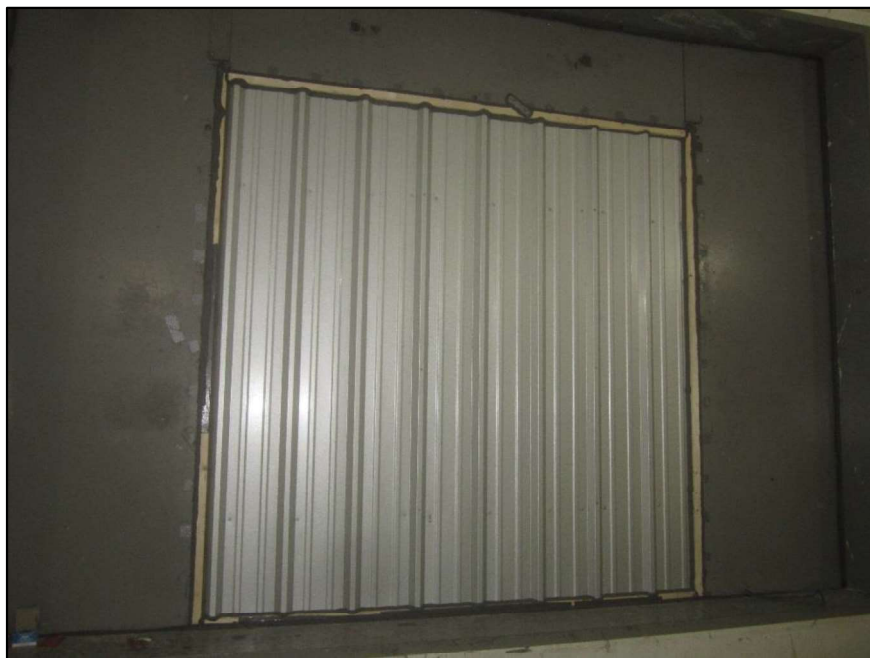
**Source Room View of Installed Specimen**

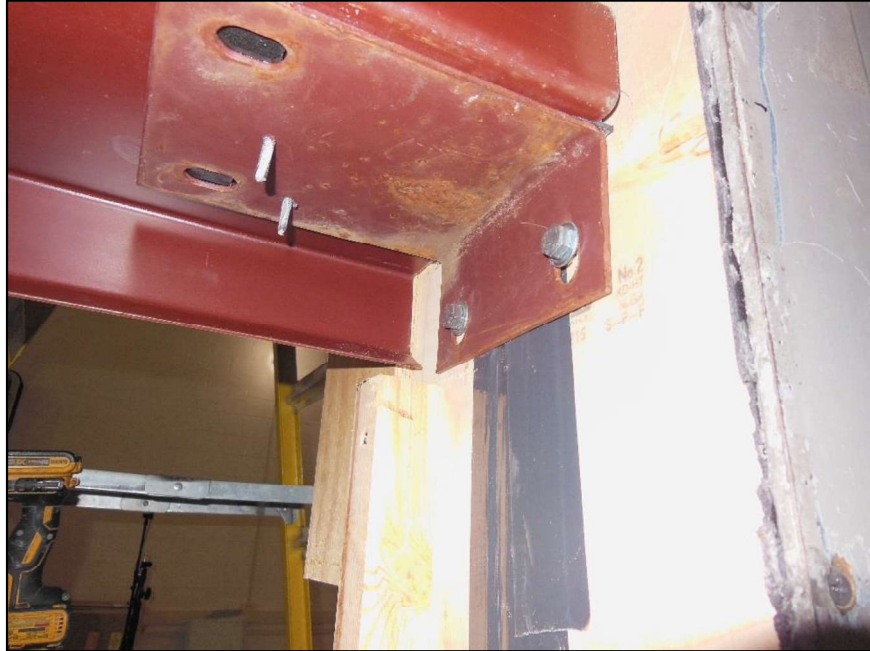
**Girt with Support Bracket**

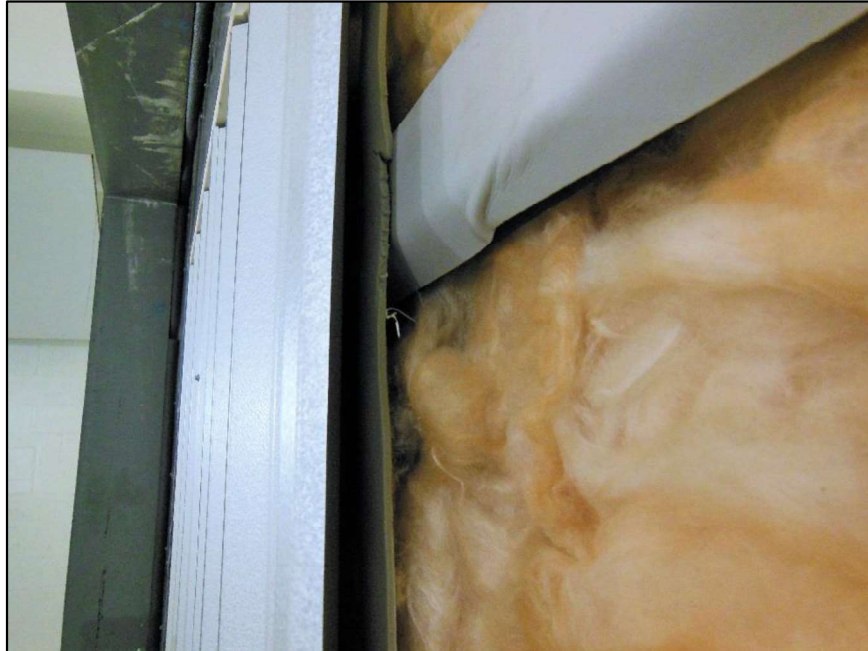
**Isolator Foam with Metal Panel**

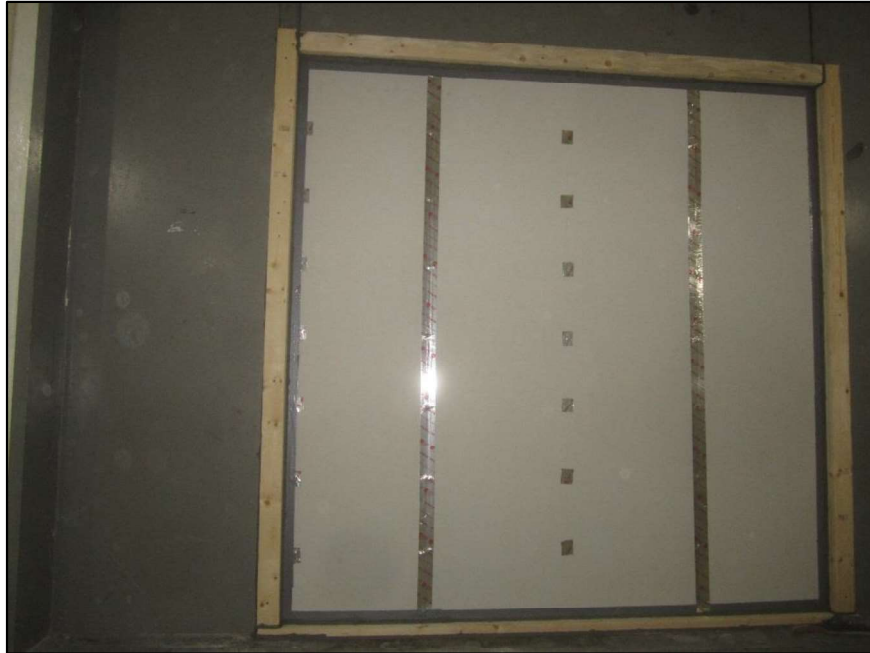
**Receive Room View of Installed Specimen**

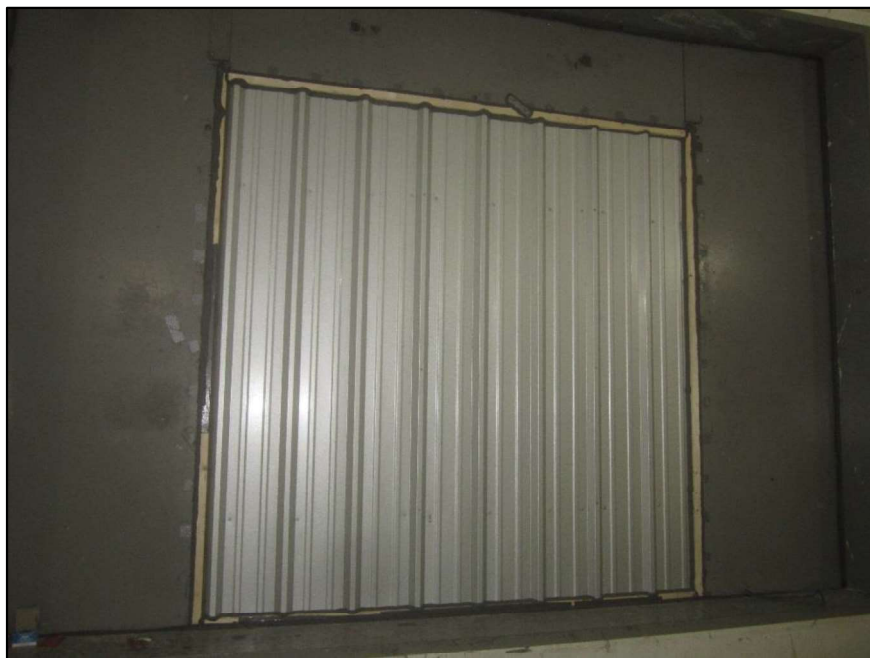
**Source Room View of Installed Specimen**

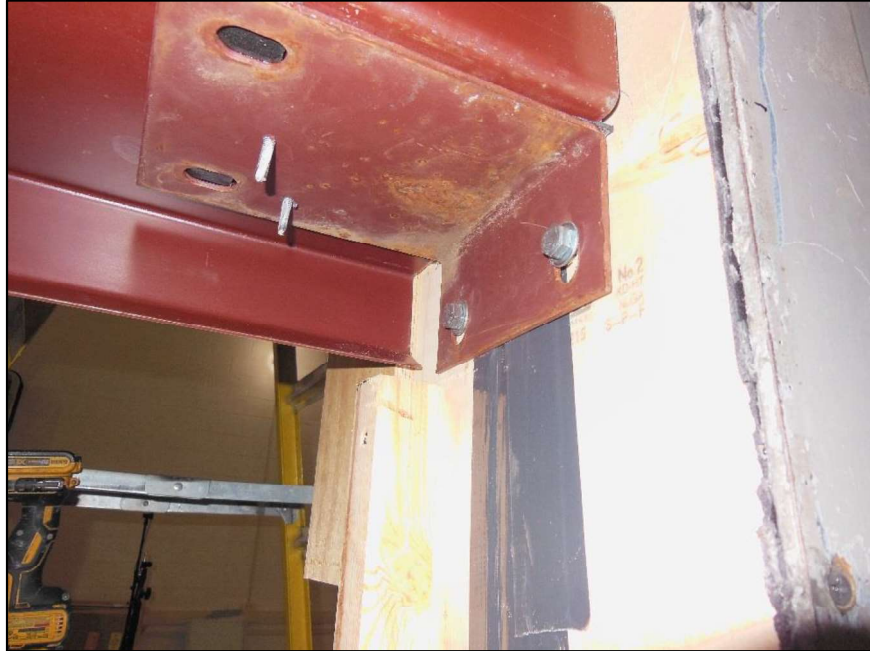
**Girt with Support Bracket**

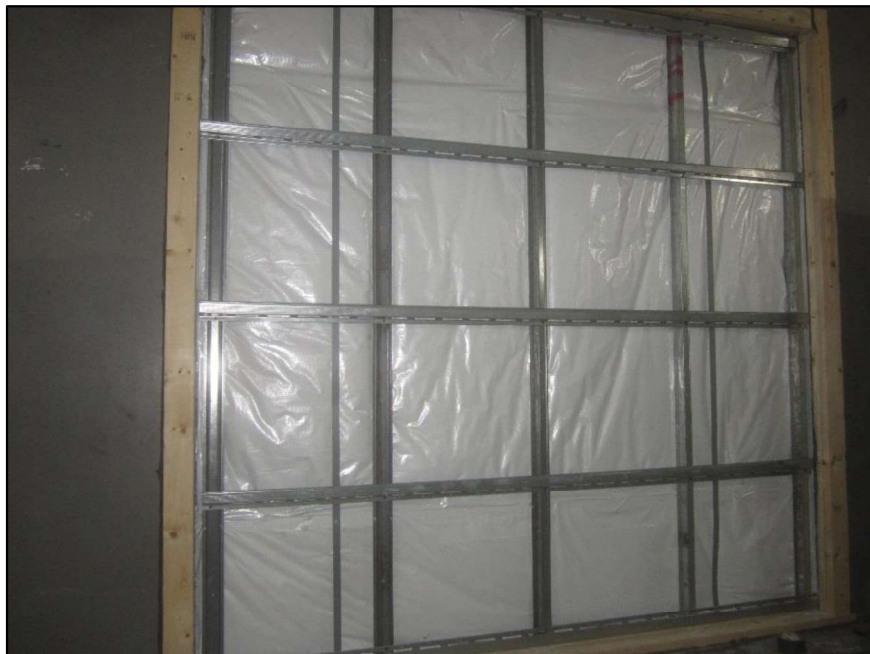
**Hat Channel and Resilient Channel**

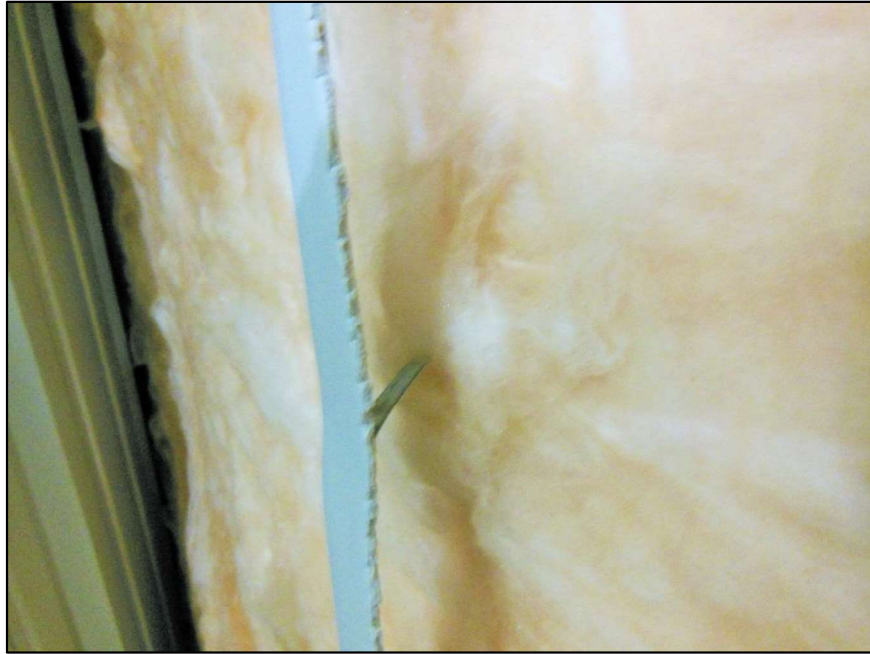
**Foam on Insulation Support and Banding**

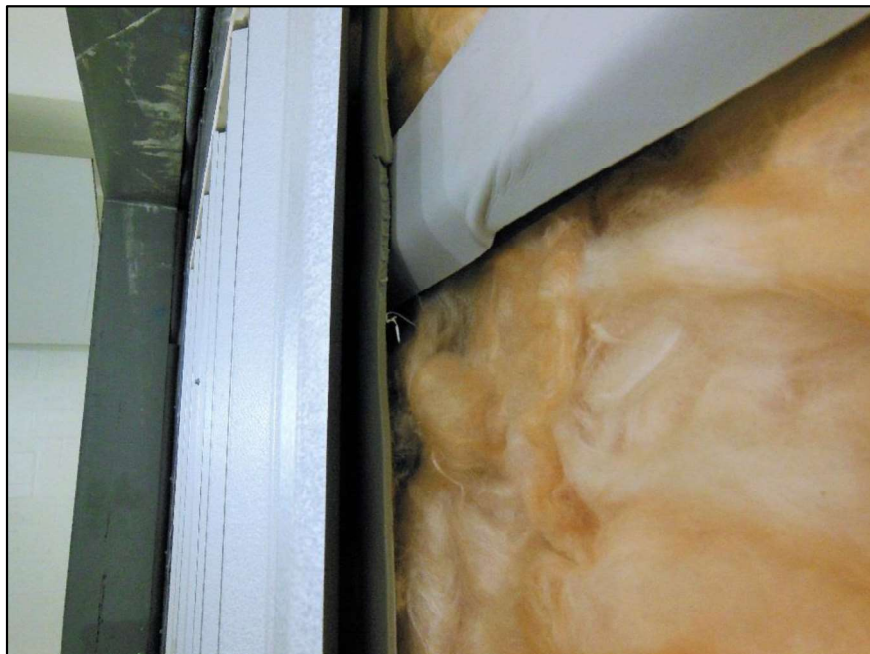
**Isolator Foam with Metal Panel**

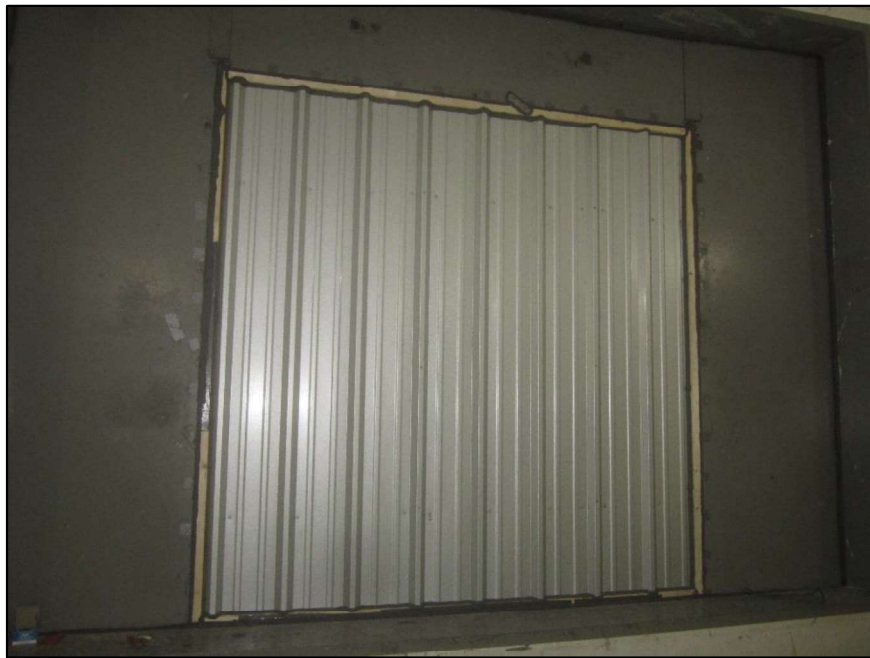
**Source Room View of Installed Specimen**

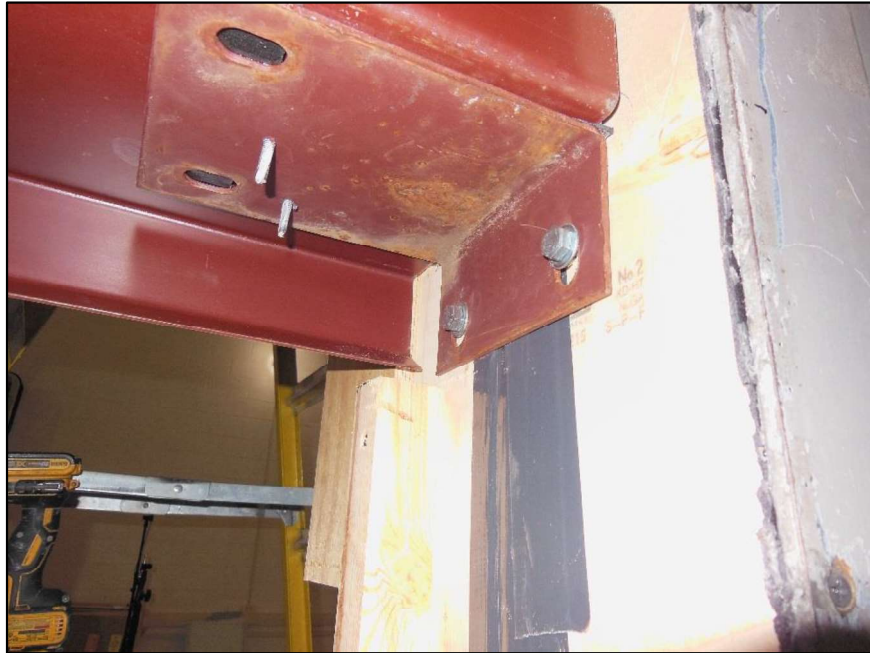
**Girt with Support Bracket**

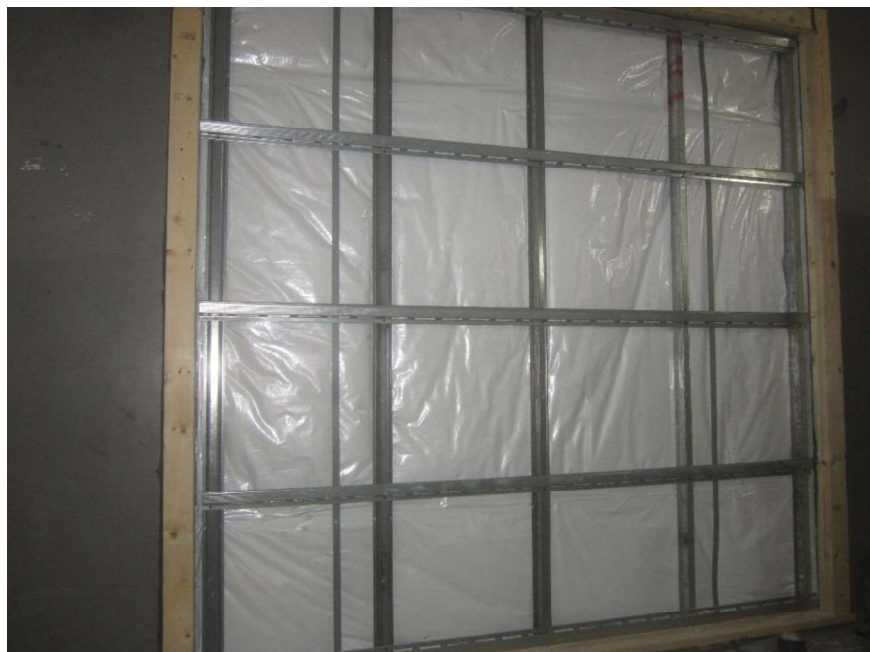
**Hat Channel and Resilient Channel**

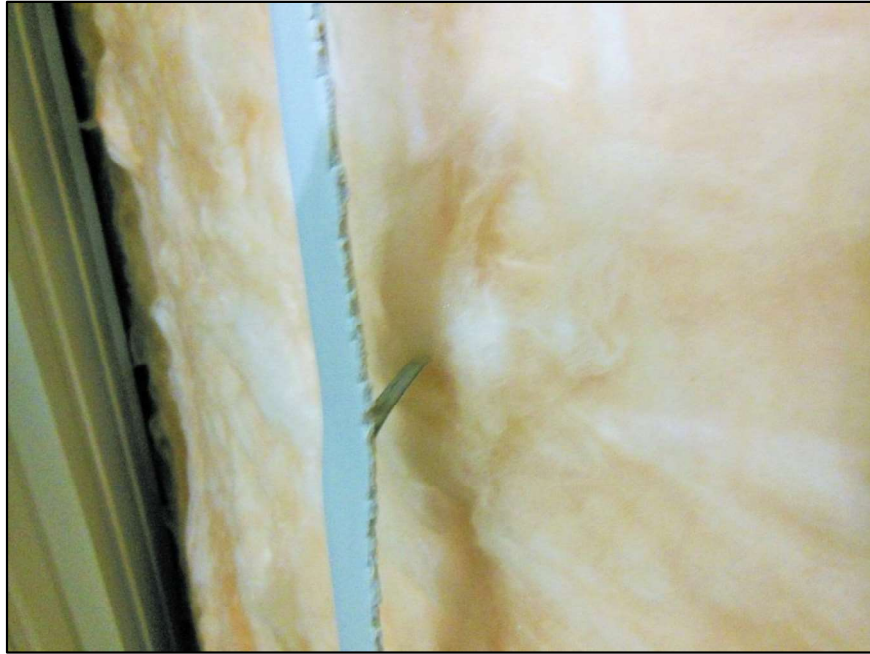
**Foam on Insulation Support and Banding**

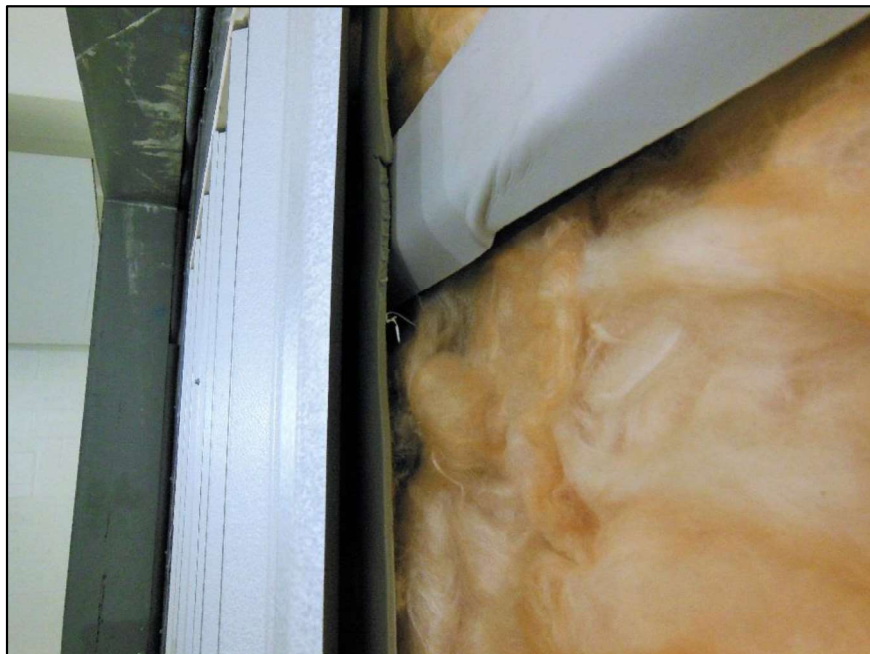
**Isolator Foam with Metal Panel**

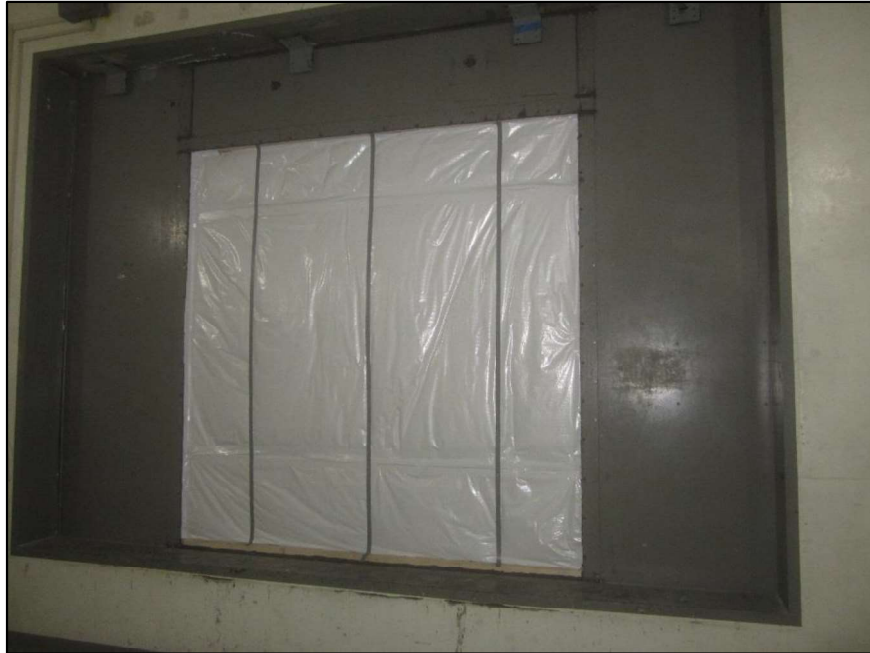
**Receive Room View of Installed Specimen**

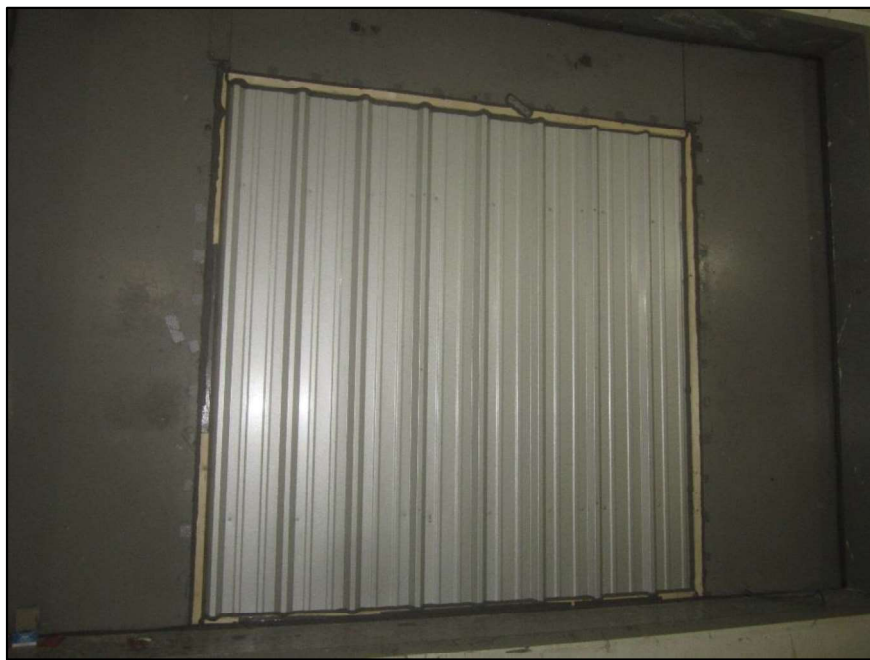
**Source Room View of Installed Specimen**

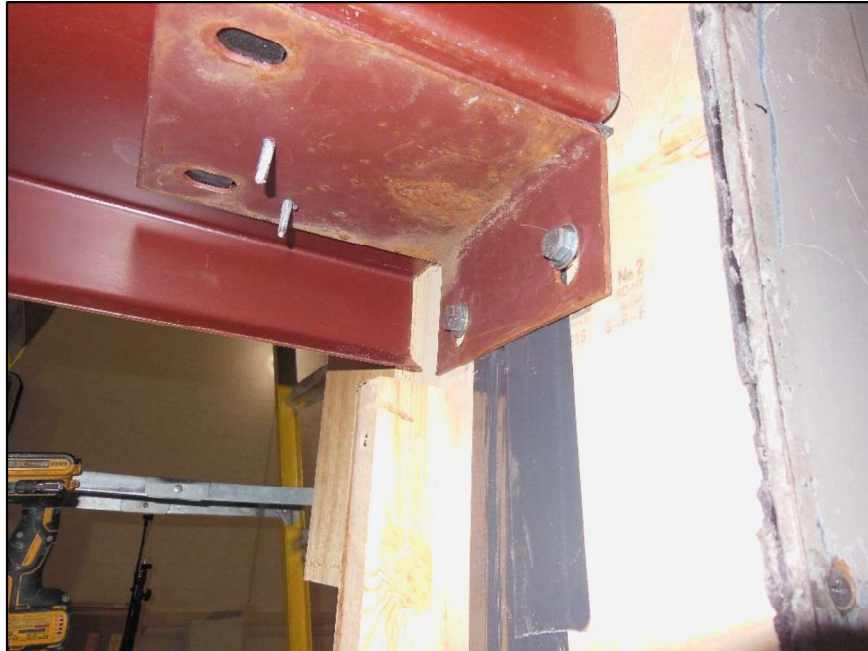
**Girt with Support Bracket**

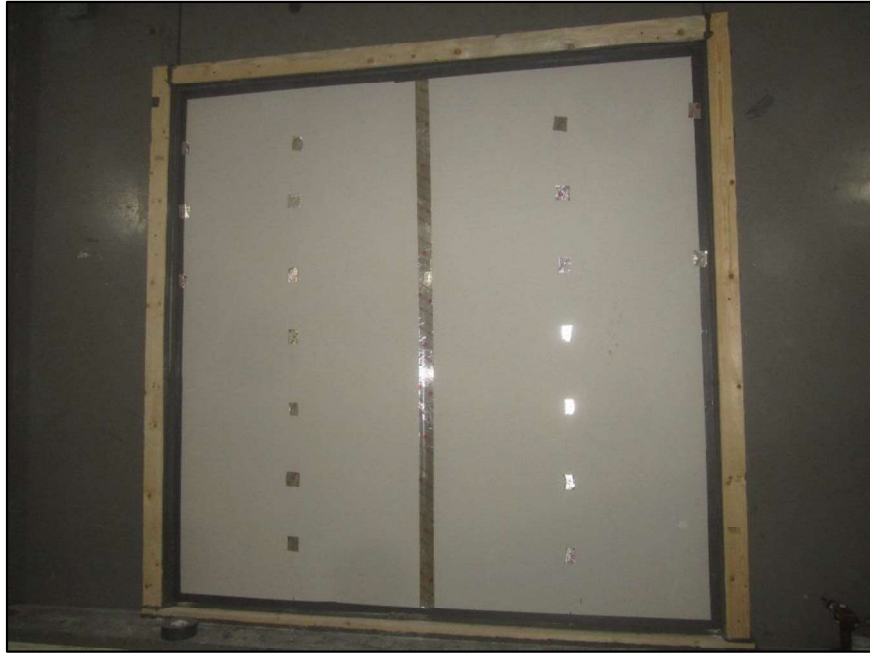
**Receive Room View of Installed Specimen**

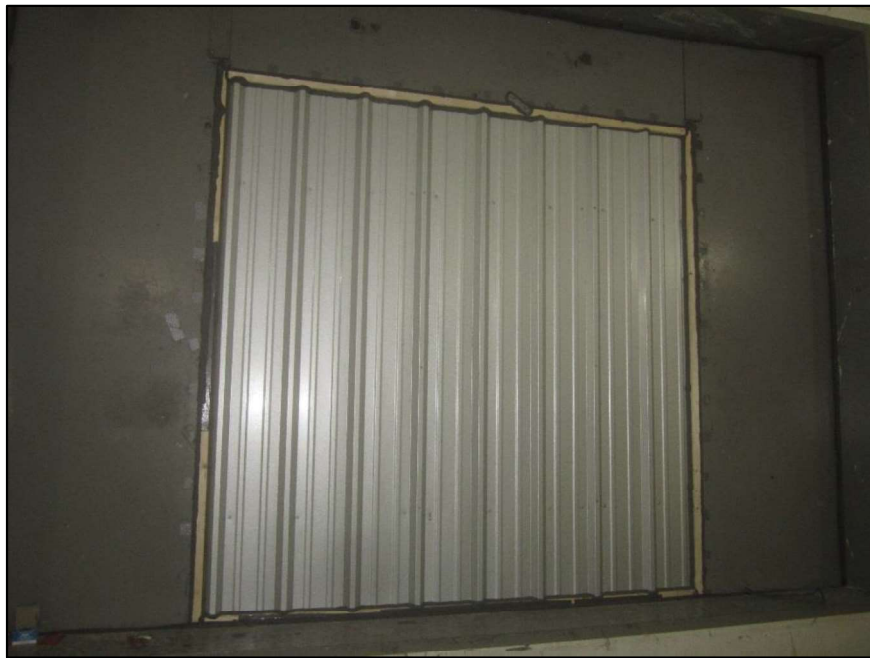
**Source Room View of Installed Specimen**

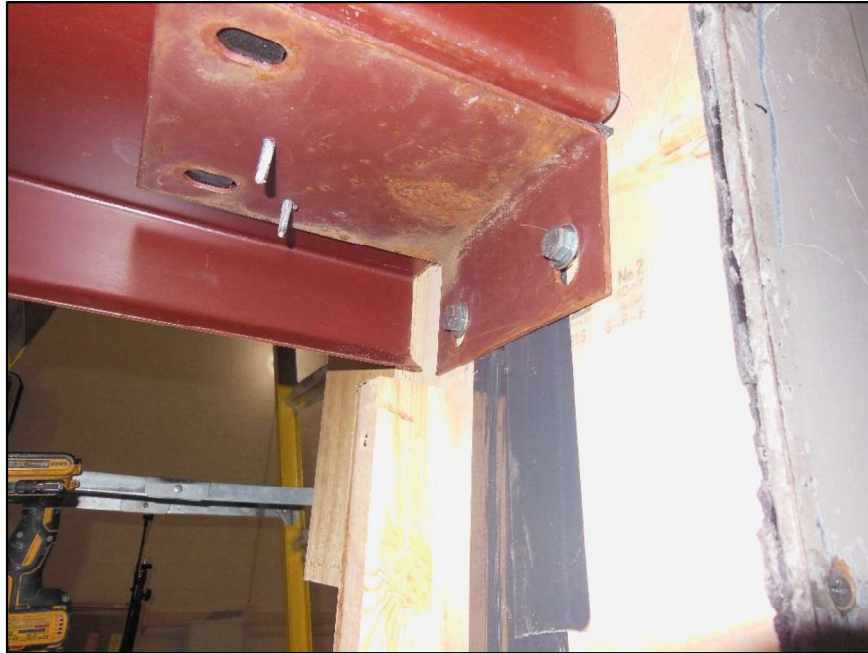
**Girt with Support Bracket**
